**Device** TC1797  
**Marking/Step** QS-AC  
**Package** P/PG-BGA-416-10

## 01961AERRA

This Errata Sheet describes the deviations from the current user documentation.

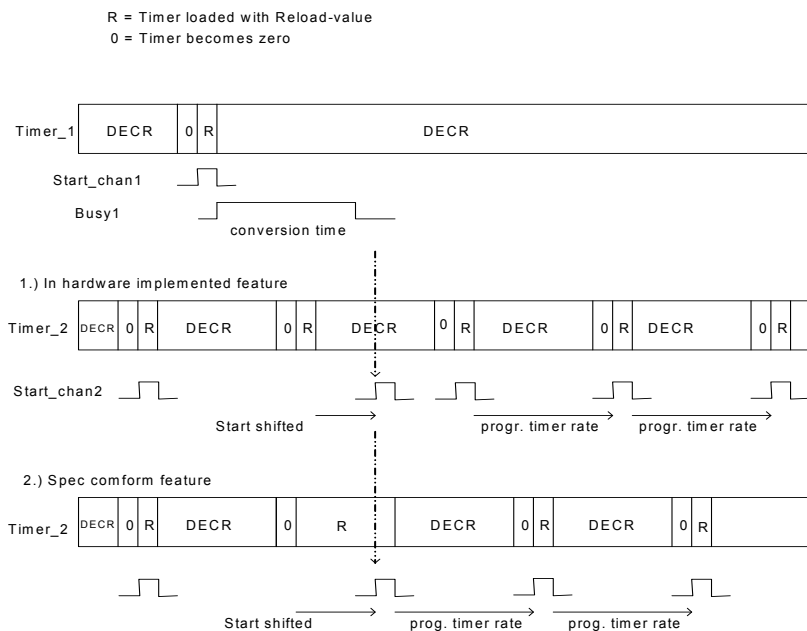
**Figure 1 Timing concerning equidistant multiple timers**

The correct behavior would be a reload when the requested conversion (of channel\_2) is started.

Therefore the start of conversion for channel\_2 is delayed by maximum one conversion-time. After this delay it will be continued with equidistant conversion-starts. Please refer to the following figure.

Note: the programmed timer rate is much longer than the conversion time, this means that the fault is much smaller than in the picture

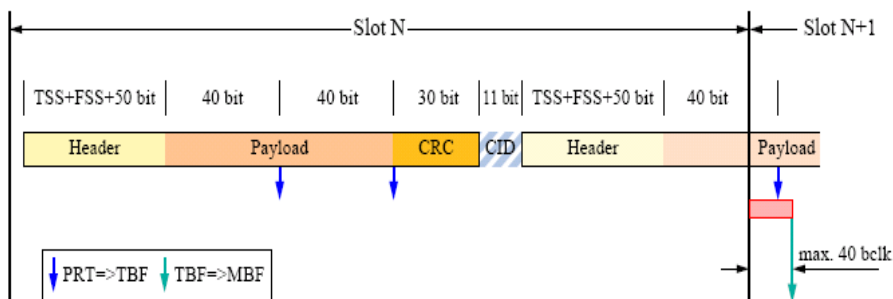
**Figure 2 The second frame starts in the same slot**

The erratum is limited to cases where the complete header and a part of the payload of another frame is received in slot N.

The transfer of a received valid frame from TBF to MBF is initiated by the end of the actual slot. Execution is started not later than 40 bclk periods after the slot change. 40 bclk periods equate 10 bit times, when  $\text{bclk}=40\text{MHz}$ . Corruption of payload occurs when a transfer from PRT to TBF happens in the red marked time window between start of new slot and start of transfer from TBF to MBF.

1. Ensure that the static slot length is configured suited to the static payload length.
2. Check Message Buffer Status for boundary violation.

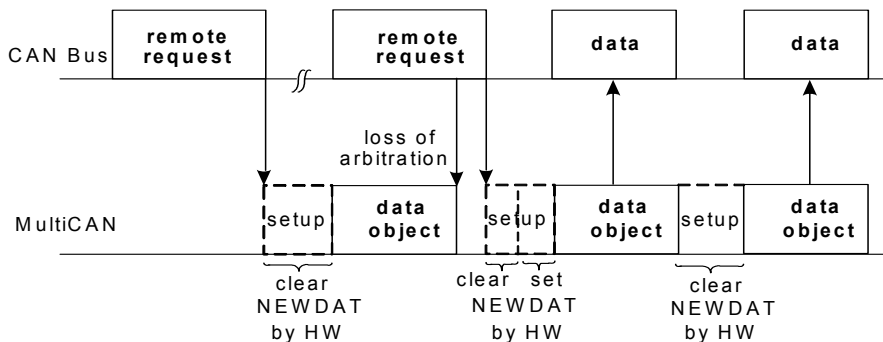
**Figure 3 Loss of Arbitration**

When the appropriate message object (data frame) triggered by the first remote frame wins the arbitration, it will be sent out and `NEWDAT` is not reset. This leads to an additional data frame, that will be sent by this message object (clearing `NEWDAT`).

There will, however, not be more data frames than there are corresponding remote requests.
