Cortina Systems® LXT971A, LXT972A, LXT972M Single-Port 10/100 Mbps PHY Transceivers

Specification Update

15 March 2007

Revision 13.0

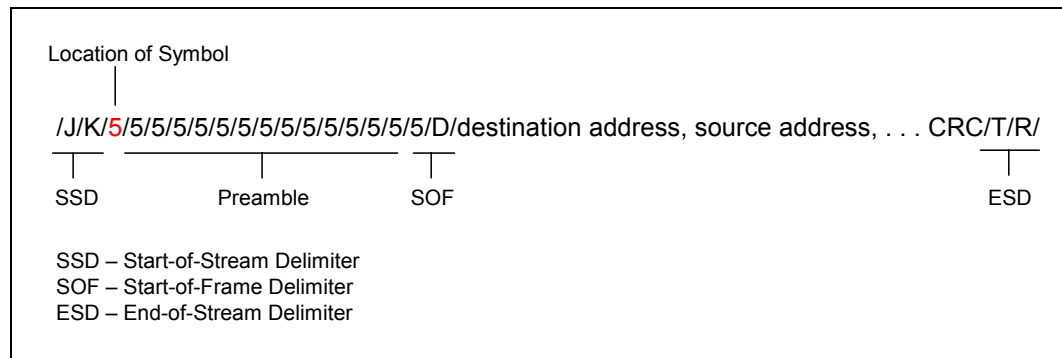
Problem An illegal symbol placed immediately after the SSD (preamble after JK) is not detected. However, any subsequent corrupt symbol will be detected.

Implication RXER does not assert if this symbol location is corrupted. However, an error in this location does not affect packet integrity.

Workaround Use the MAC layer protocol to detect corrupt symbols in the packet.
