Intel[®] Communications Chipset 8900 Series

Specification Update

June 2016

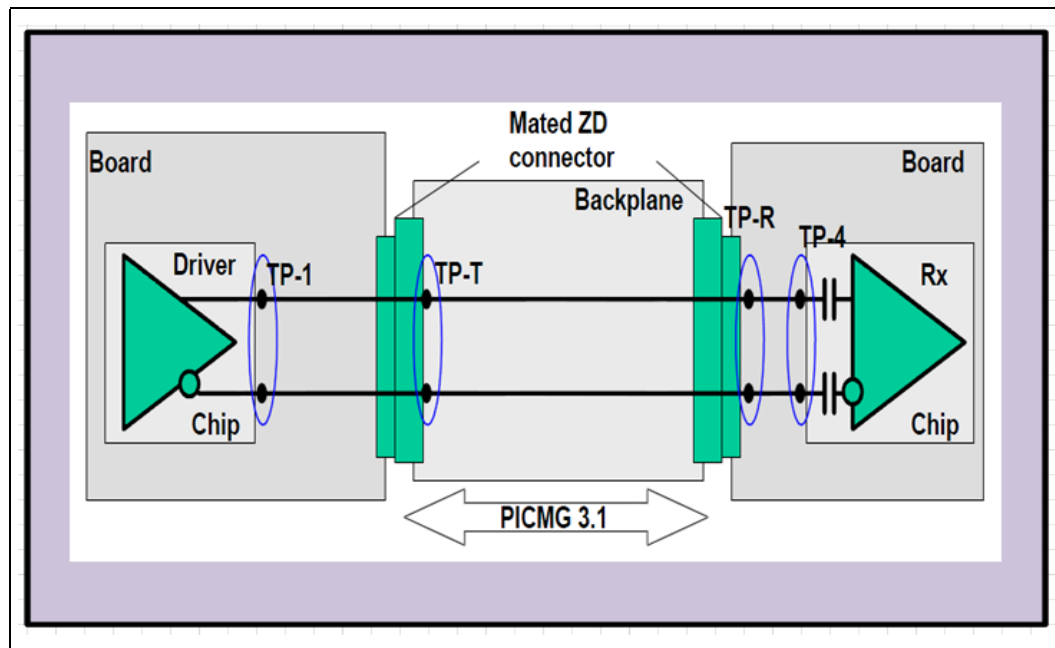
Figure 2. 1000BASE-BX/FC-PI Transmitter Electrical Specifications

75. GbE: GbE Interface Transmit Voltage Level Specification Violation

Implication: Although this is a specification violation, it does not affect the functional operation of the interface.

Workaround: Ensure that the signal routing length from TP-1 to TP-4 is greater than 10". Refer to *Intel® Communications Chipset 8900 Series Platform Design Guide (PDG)* for maximum routing length. (See Figure 2.)
