Intel[®] 82576EB Gigabit Ethernet Controller Specification Update

Revision 3.0
August 2015

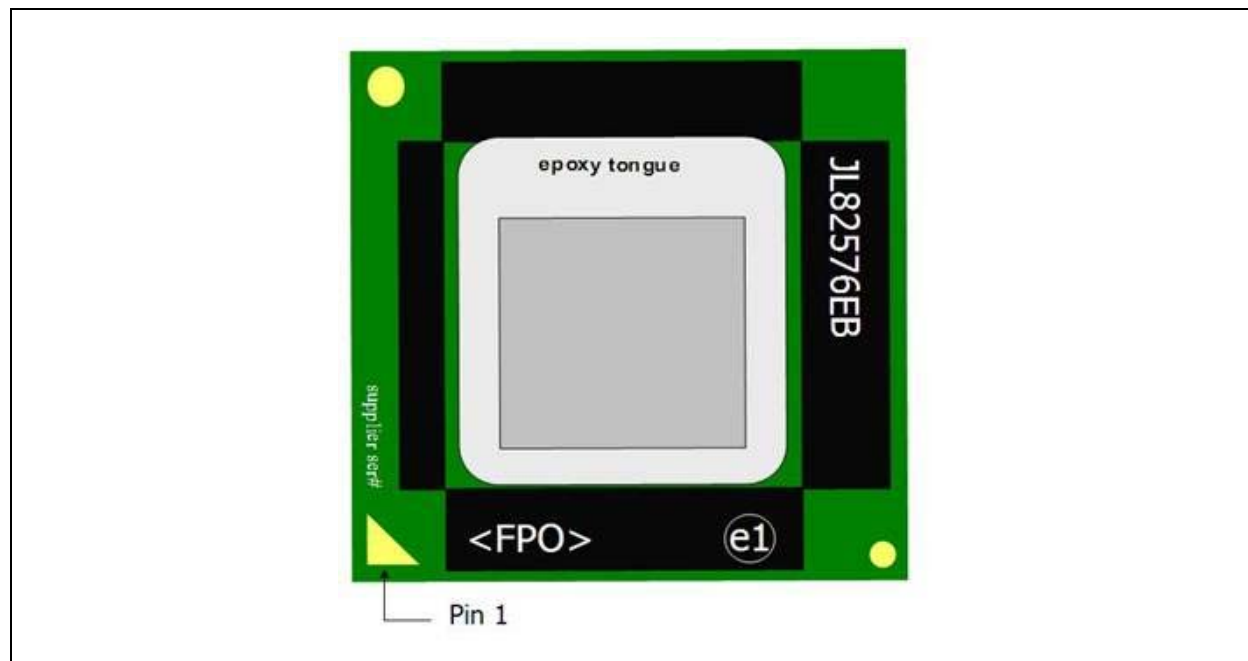
Figure 1. Example With Identifying Marks

There is an internal designator visible as a dash on the die side of some packages. It’s location may differ. The mark (looks like a dash, approximately 300X1000 µm in size) does not impact function.
