Active Errata List

CAN Microcontrollers

T89C51CC01
T89C51CC01UA
T89C51CC01CA

Errata Sheet

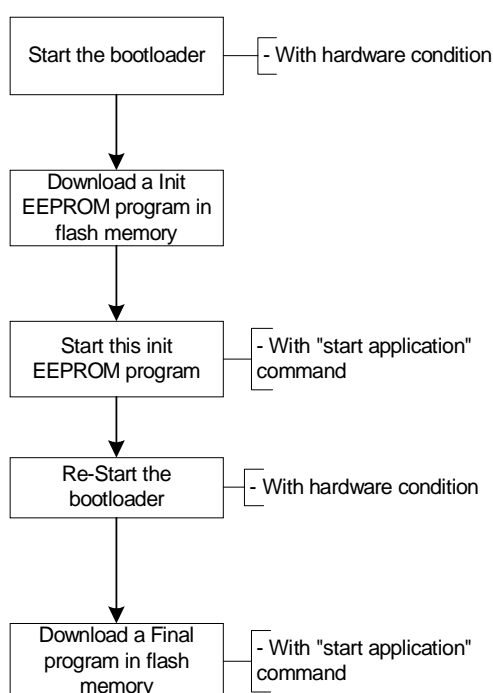
16. EEPROM – Lock-up during ISP write

Program lock-up can be experienced when using Atmel FLIP software or a custom In system Pogramming tools to write in the internal EEPROM. This problem occurs with clock frequency > 12MHz in X2 mode or 24MHz in X1 mode. Neither the code Flash nor the EEPROM are corrupted by the lock-up. Although the EEPROM cannot be written by the bootloader.

This problem is bootloader related and doesn't affect the capability for the user to read and write into the EEPROM. This problem is technology dependant. The likelihood of experiencing the problem is low at Clock frequency > 24 MHz in X1 mode and non-existent below. A reset can be applied to recover from the lock-up.

Workaround

The following process can be done to work around the problem.

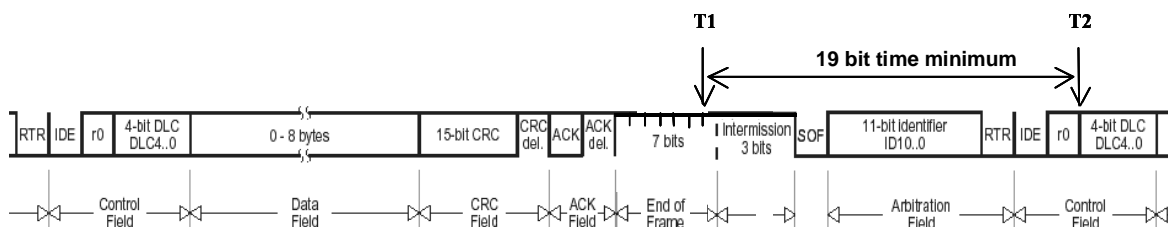
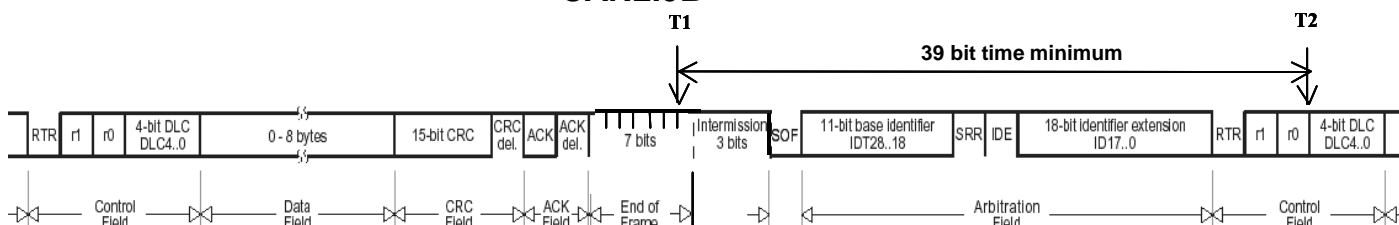
17. Transmission after a 3 bit Intermessage

If a Transmit Message Object (MOB) is enabled while the CAN bus is busy with an on going message, the transmitter will wait for the 3-bit Intermession before starting its transmission. This is in full agreement with the CAN recommendation.

1. At least one Receive MOB of the chip are programmed to accept the incoming message. In this case, the transmitter will wait for the next 3-bit Intermission to retry its transmission.
2. No Receive MOB of the chip are programmed to accept the incoming message. In this case the transmitter will wait for a 4-bit Intermission to retry its transmission. In this case, any other CAN nodes ready to transmit after a 3-bit Intermission will start transmit before the chip transmitter, even if their messages have lower priority IDs.

Always have a Receive MOB enabled ready to accept any incoming messages. Thanks to the implementation of the CAN interface, a Receive MOB must be enable at latest, before the 1st bit of the DLC field. The Receive MOB status register is written (RXOK if message OK) immediately after the 6th bit of the End of Frame field. This will leave in CAN2.0A mode a minimum 19-bit time delay to respond to the end of message interrupt (RXOK) and re-enable the Receive MOB before the start of the DLC field of the next incoming message. This minimum delay will be 39-bit time in CAN2.0B. See CAN2.0A CAN2.0B frame timings below.

The workaround is to have the last MOB (MOB14) as "spy" enabled all the time; it is the MOB of lowest priority : If a Mob other than MOB14 is programmed in receive mode and its acceptance filter matches with the incoming message ID, this Mob will take the message. MOB14 will only take messages than no other MOB's will have accepted. MOB14 will need to be re-enabled fast enough to manage back to back frames. The deadline to do this is the beginning of DLC slot of incoming frames as explained above.

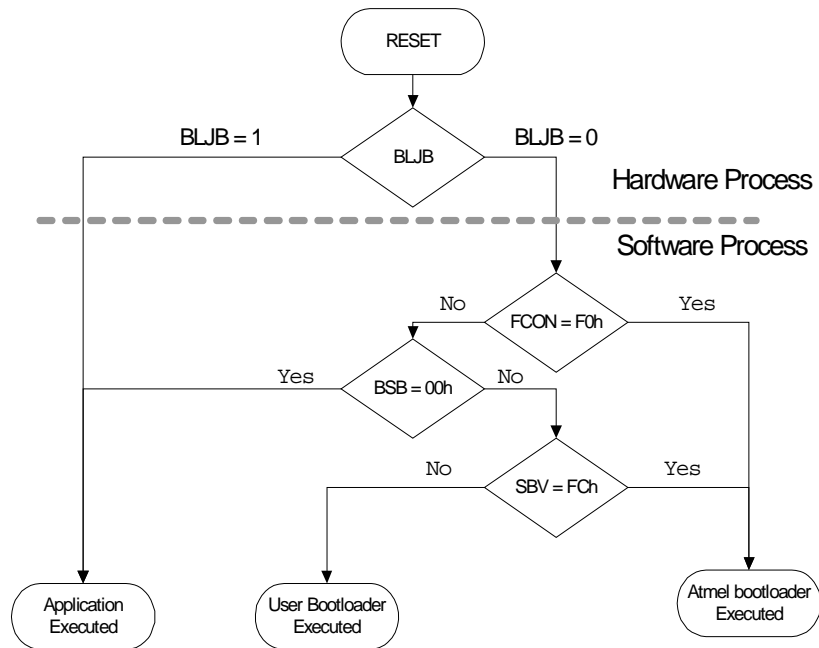
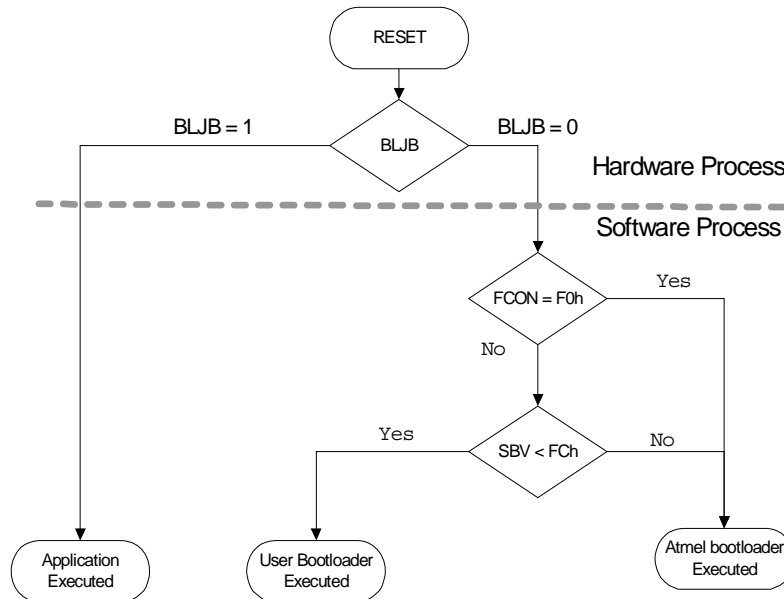
4. Boot Process Compatibility

There are some differences between Boot process of bootloader 1.2 and newer versions (see below).

Use the fuse bit BLJB to start the application in both versions.
