Active Errata List

CAN Microcontrollers

T89C51CC01
T89C51CC01UA
T89C51CC01CA

Errata Sheet

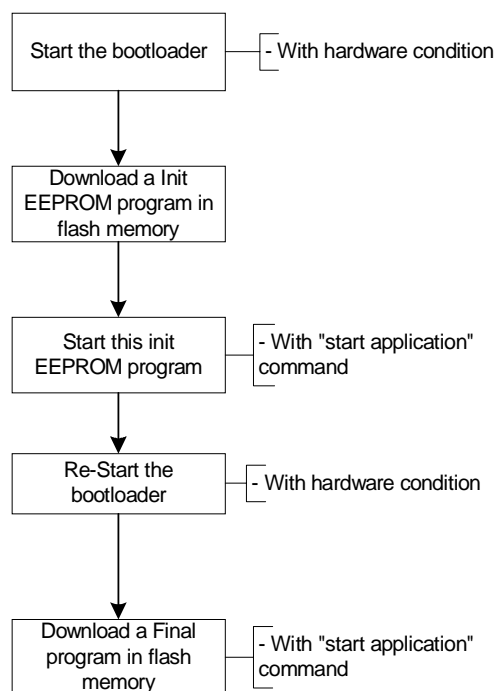
16. EEPROM – Lock-up during ISP write

Program lock-up can be experienced when using Atmel FLIP software or a custom In system Pogramming tools to write in the internal EEPROM. This problem occurs with clock frequency > 12MHz in X2 mode or 24MHz in X1 mode. Neither the code Flash nor the EEPROM are corrupted by the lock-up. Although the EEPROM cannot be written by the bootloader.

This problem is bootloader related and doesn't affect the capability for the user to read and write into the EEPROM. This problem is technology dependant. The likelihood of experiencing the problem is low at Clock frequency > 24 MHz in X1 mode and non-existent below. A reset can be applied to recover from the lock-up.

The following process can be done to work around the problem.

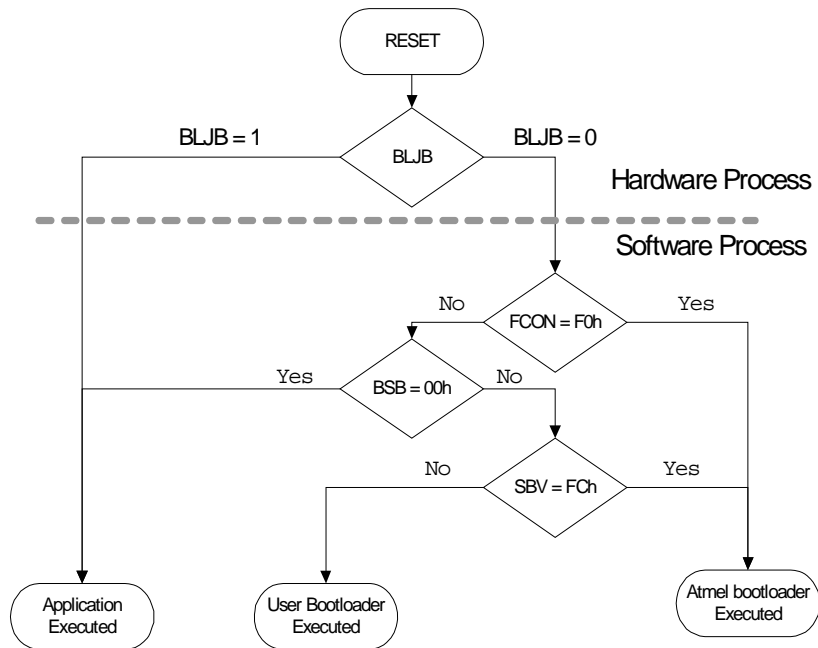
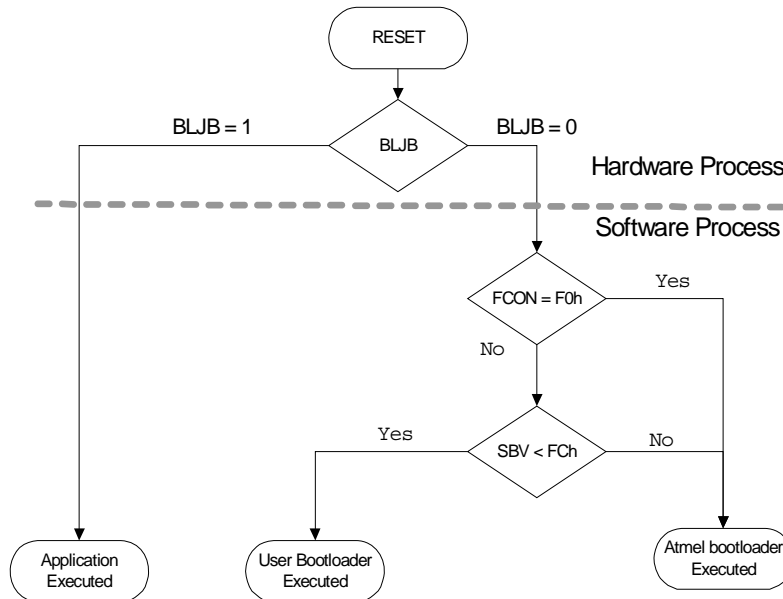
4. Boot Process Compatibility

There are some differences between Boot process of bootloader 1.2 and newer versions (see below).

Use the fuse bit BLJB to start the application in both versions.
