dsPIC33EPXXXGS70X/80X Family Silicon Errata and Data Sheet Clarification

The dsPIC33EPXXXGS70X/80X family devices that you have received conform functionally to the current Device Data Sheet (DS70005258C), except for the anomalies described in this document.

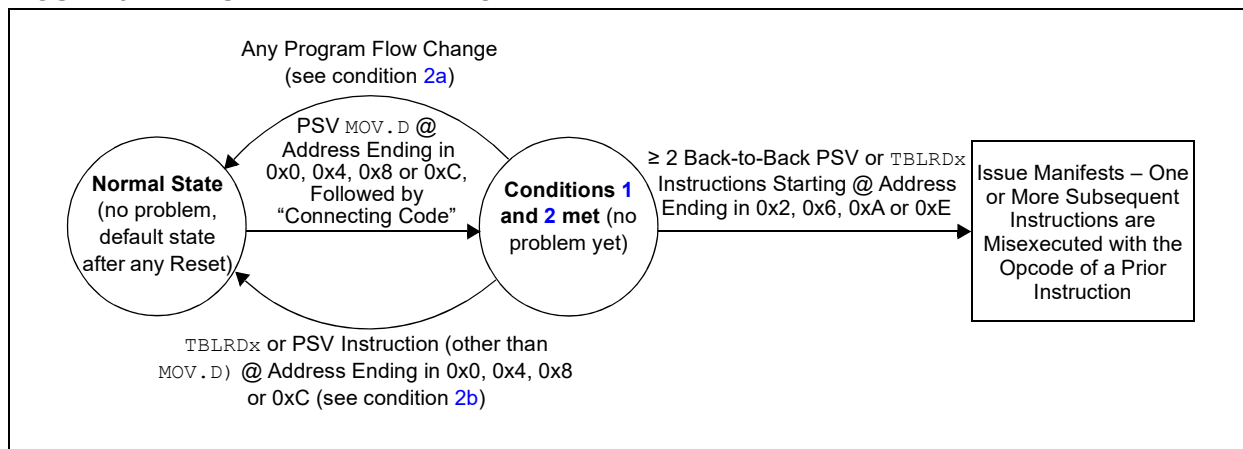
FIGURE 3: SIMPLIFIED BEHAVIOR

When two or more data Flash read instructions (via Program Space Visibility (PSV) read or Table Read) are executed back-to-back, one or more subsequent instructions can be misexecuted when all of the conditions in [Table 4](#) occur.

1. A PSV <code>MOV.D</code> instruction is executed, with opcode at address ending in 0x0, 0x4, 0x8 or 0xC; and
2. Some “connecting code” is executed (following the <code>MOV.D</code> of condition 1), with the properties: <ul style="list-style-type: none">a) The connecting code does not include any program flow changes, including: taken branch instructions (including all versions of <code>BRA</code>, <code>CPBEQ</code>, <code>CPBGT</code>, <code>CPBLT</code>, <code>CPBNE</code>), <code>CALL</code>, <code>CALL.L</code>, <code>GOTO</code>, <code>GOTO.L</code>, <code>RCALL</code>, <code>RETLW</code>, <code>RETURN</code>, vectoring to an ISR, returning from an interrupt (<code>RETFIE</code>) and certain debug operations, such as break and one-step; andb) The connecting code does not include a <code>TBLRDx</code> or non-<code>MOV.D</code> PSV instruction, located at a Flash memory address ending in 0x0, 0x4, 0x8 or 0xC; andc) The connecting code is at least two instruction words in length; andd) The connecting code does not end with a <code>REPEAT</code> instruction, with count > 0; and

3. ≥ 2 back-to-back PSV or <code>TBLRDx</code> instructions are executed (following the code of condition 2), where the first of the back-to-back instructions is located at an address ending in 0x2, 0x6, 0xA or 0xE.

[Figure 3](#) provides an example of the effective behavior.

The issue can be avoided by ensuring any one or more of the requirements are not met. For example:

1. All instances of PSV `MOV.D` can be replaced with two PSV `MOV` instructions instead. Non-PSV `MOV.D` instructions acting on RAM/SFRs do not need to be modified; or
2. If not already present, a program flow change instruction (such as `BRA $+2`) can be inserted above back-to-back data Flash read sequences; or
3. Back-to-back data Flash read instruction sequences can be broken up by inserting a non-Flash read instruction (such as a `NOP`), in between the Flash read instructions; or
4. The alignment of the code can be shifted to avoid the required opcode location addresses.

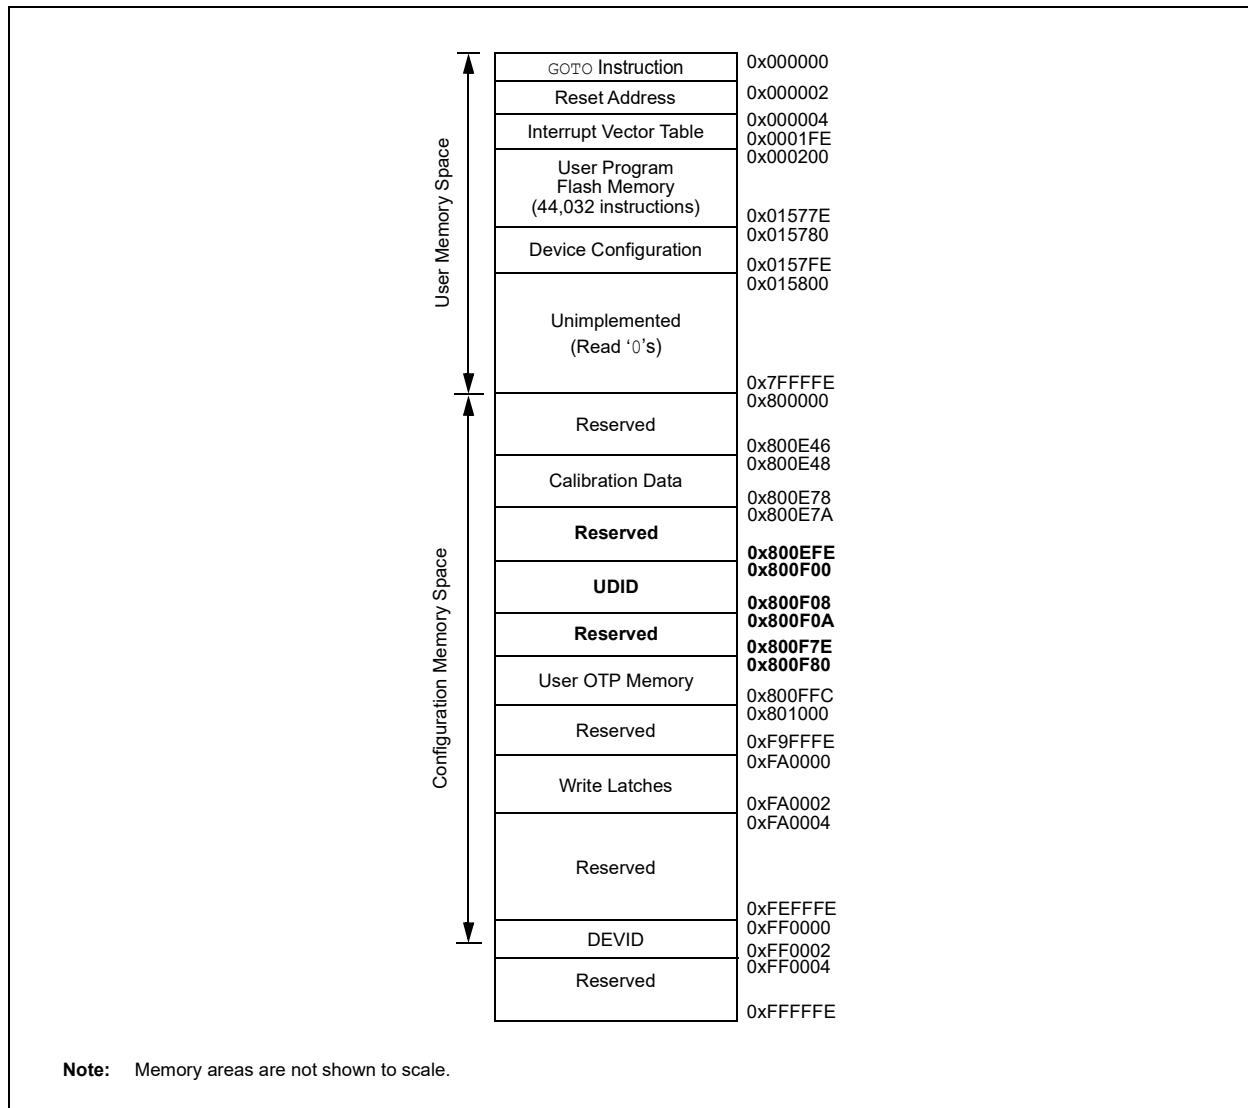
FIGURE 4-2: PROGRAM MEMORY MAP FOR dsPIC33EP128GS70X/80X DEVICES

In Figure 4-2, the following changes have been made as shown in **bold**:
