Report Title: MATE-Ax 4P Sealed
Report Number: WE-20201175
Revision: A
Date Issued: 27 January 2021

Purpose of this testing is to determine if the product meets its desired requirements.

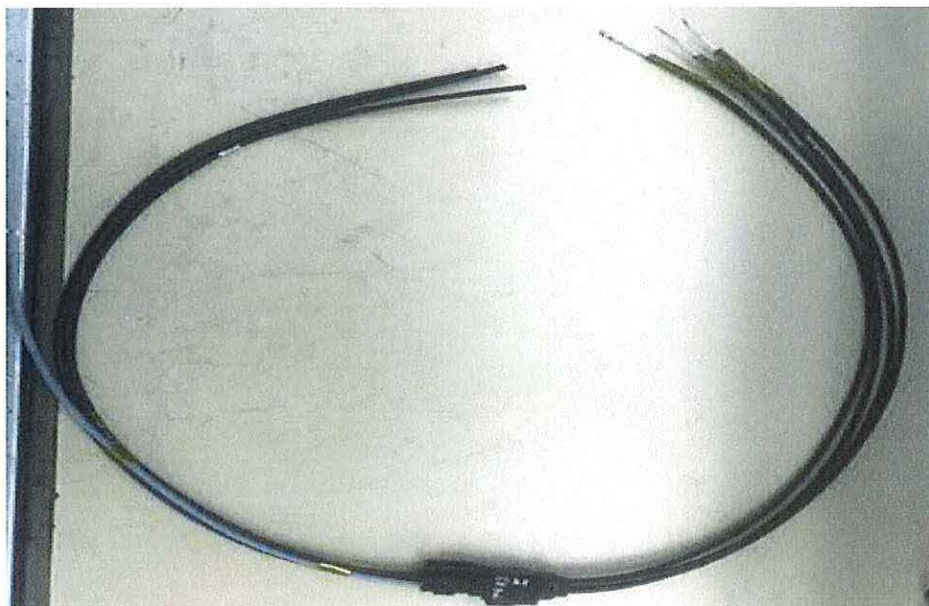
Figure 1: Sample Preparation

PG 23 Leg 2: each connector was fully populated with cavity plugs, except for one cavity on the male connector, which was populated with a single pressure tube.

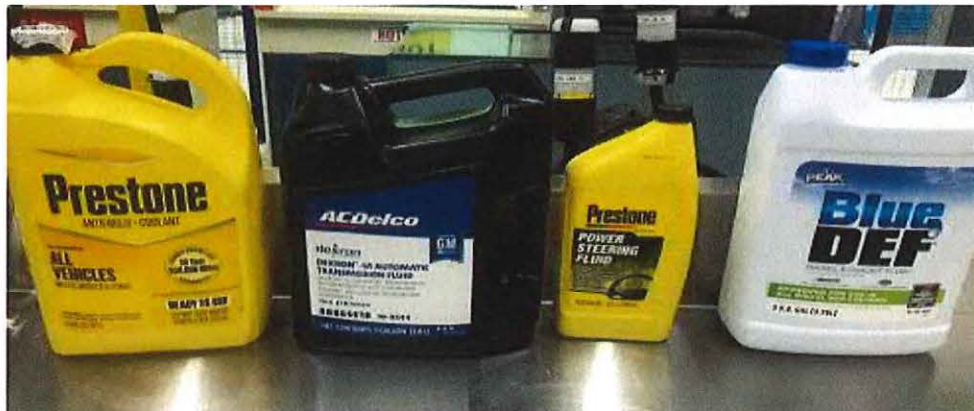
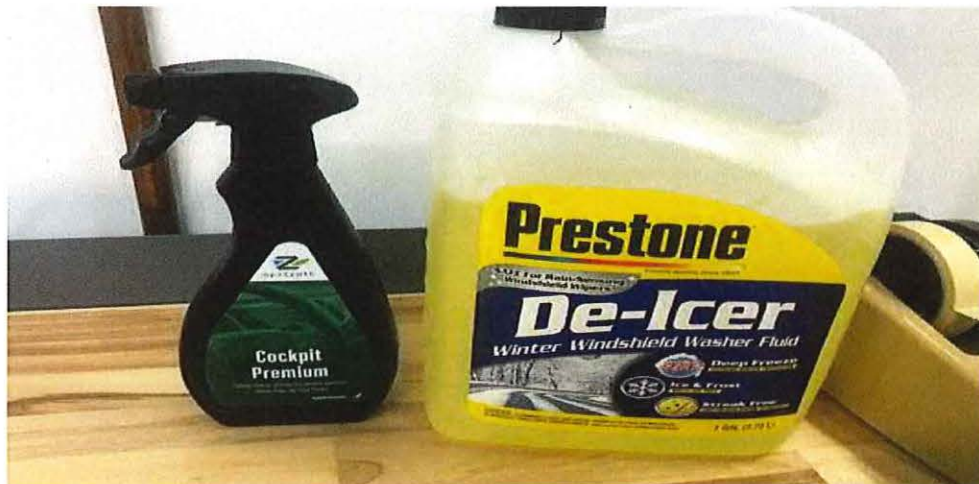
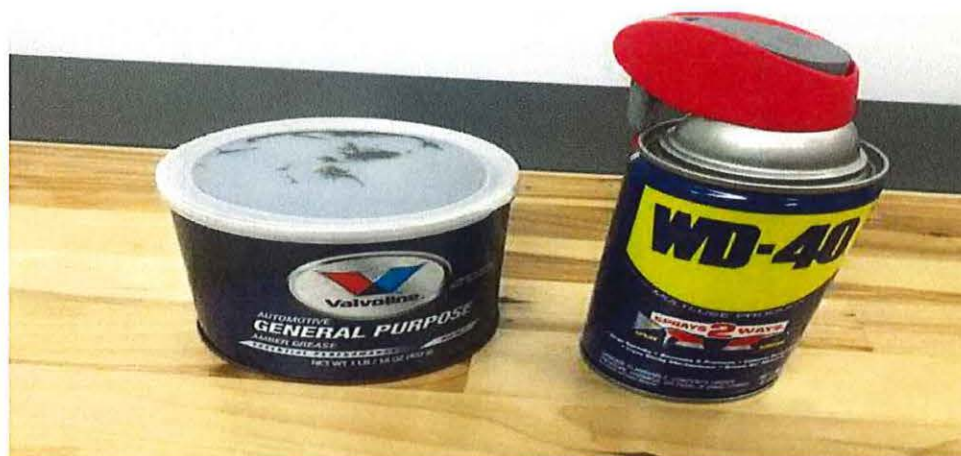
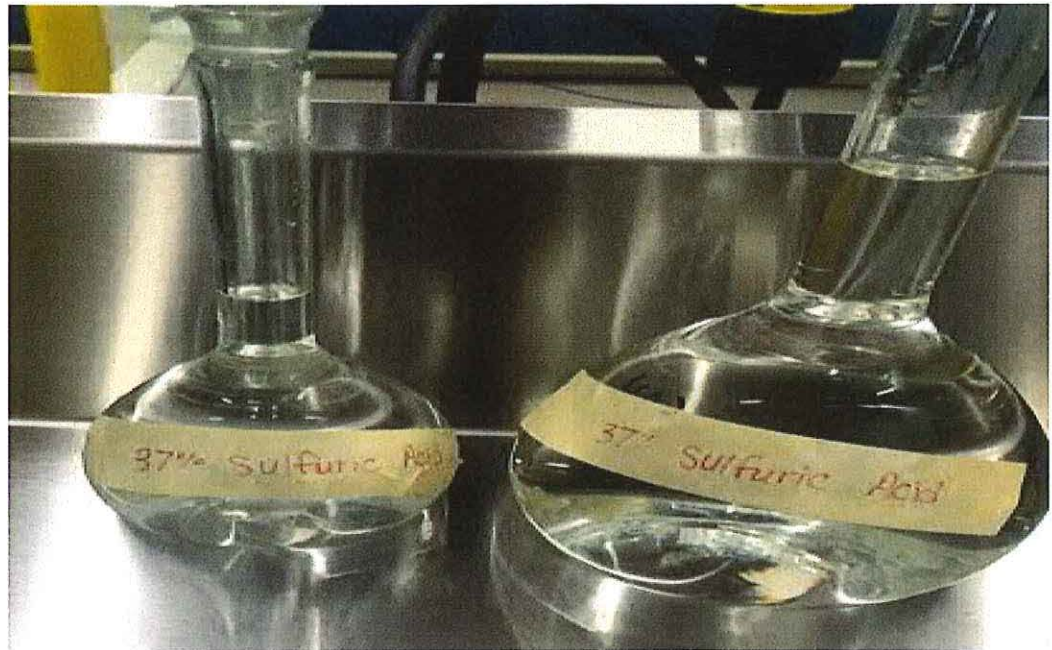
Figure 4: Fluids used in Testing

Each sample was exposed to its respective fluid by either dousing, rubbing in or spraying the chemical depending on the test specification requirements. Samples were then placed under a fume hood (room temperature) or in an oven (50°C) to age for 48 hours. After aging, samples were rinsed with water and carefully dried off before continuing to visual examination and functional checks. Images of this testing can be found in Figures 4-10.

NOTE: fluids not pictured include: Road Salt Solution, FAM Test Fuel, Diesel, Isopropanol, Brake Fluid, and Engine Oil 5W-30,

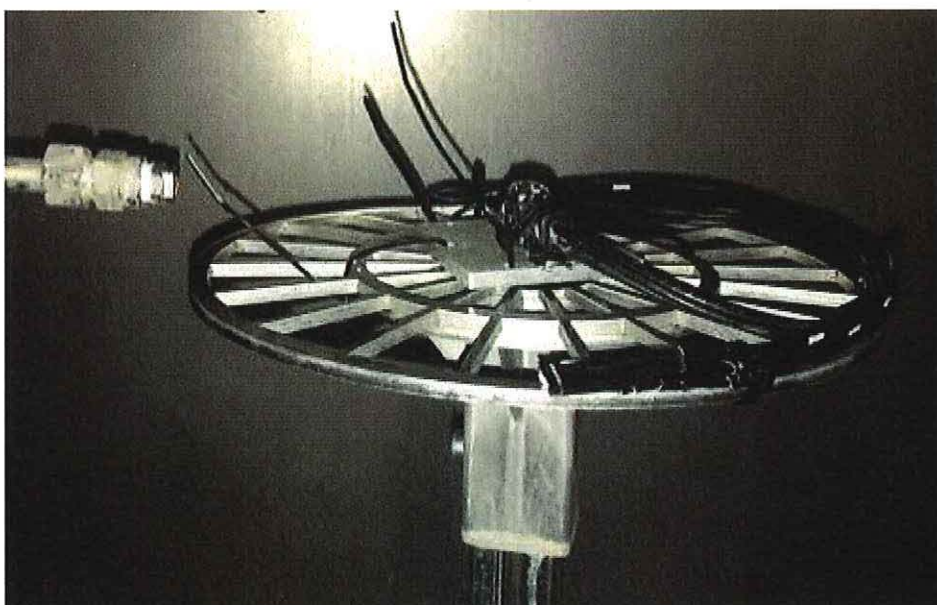
Figure 10: PG 23 Leg 1 High-Pressure Spray Setup

Each sample from Test Groups PG 23 Leg 1 and PG 23 Leg 2 experienced the same high-pressure spray testing. Samples were mounted to a rotating mount inside the water test chamber. The water nozzle was positioned in the same horizontal plane and 100-150mm away from the sample. The water pressure was set to 8MPa and the water temperature was set to 80°C. The rotating mount was set to rotate at a speed of 5rpm. The water test machine was set to spray for 60 seconds. Thus, each side of the connector would experience 15 seconds of spray time. This was repeated 3 times for each sample. Images of how samples were mounted can be found in Figures 10 and 11.

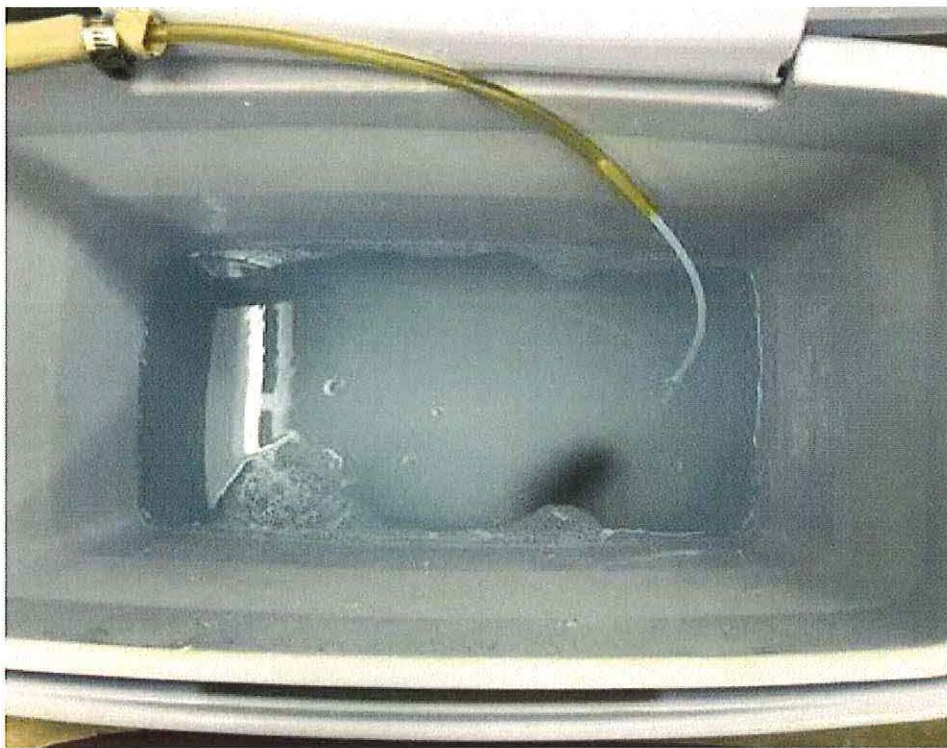
Figure 12: PG 23 Leg 2 Immersion with Pressure Difference

Each sample was connected to a vacuum and submerged under a tap water solution with 15g/L of salt and 10mL/L of dish soap. Vacuum of -10kPa was pulled for 5 minutes. The vacuum was then increased to -50kPa and was pulled for another 5 minutes. An image of this testing can be found in Figure 12.

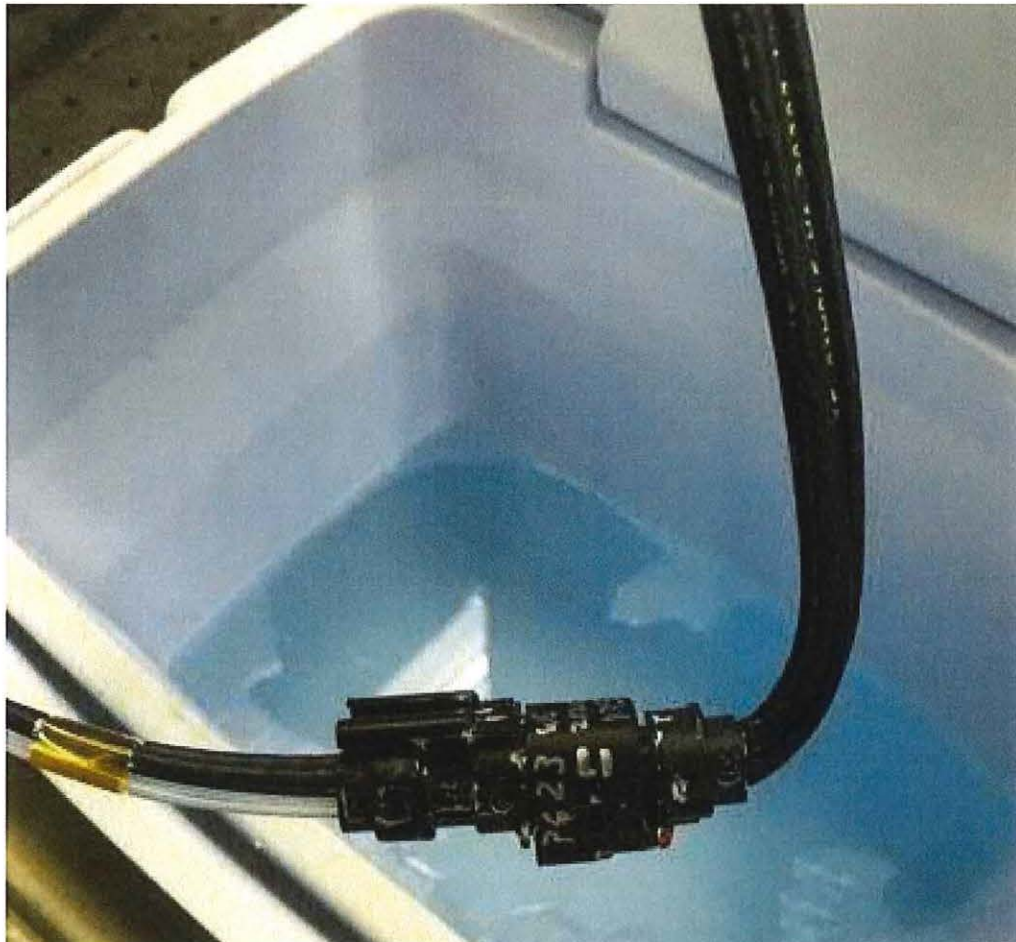
Figure 13: Line Movement During Immersion with Pressure Difference

This test was performed in the same manner as immersion with pressure difference, except the cable bundle was bent 90° with respect to the housings in the x and y planes 100mm from the back of the connector. This was performed for 10 seconds at each of the pressure settings described in immersion with pressure difference (-10kPa and -50kPa). An image of how cable bundles were bent can be found in Figure 13.

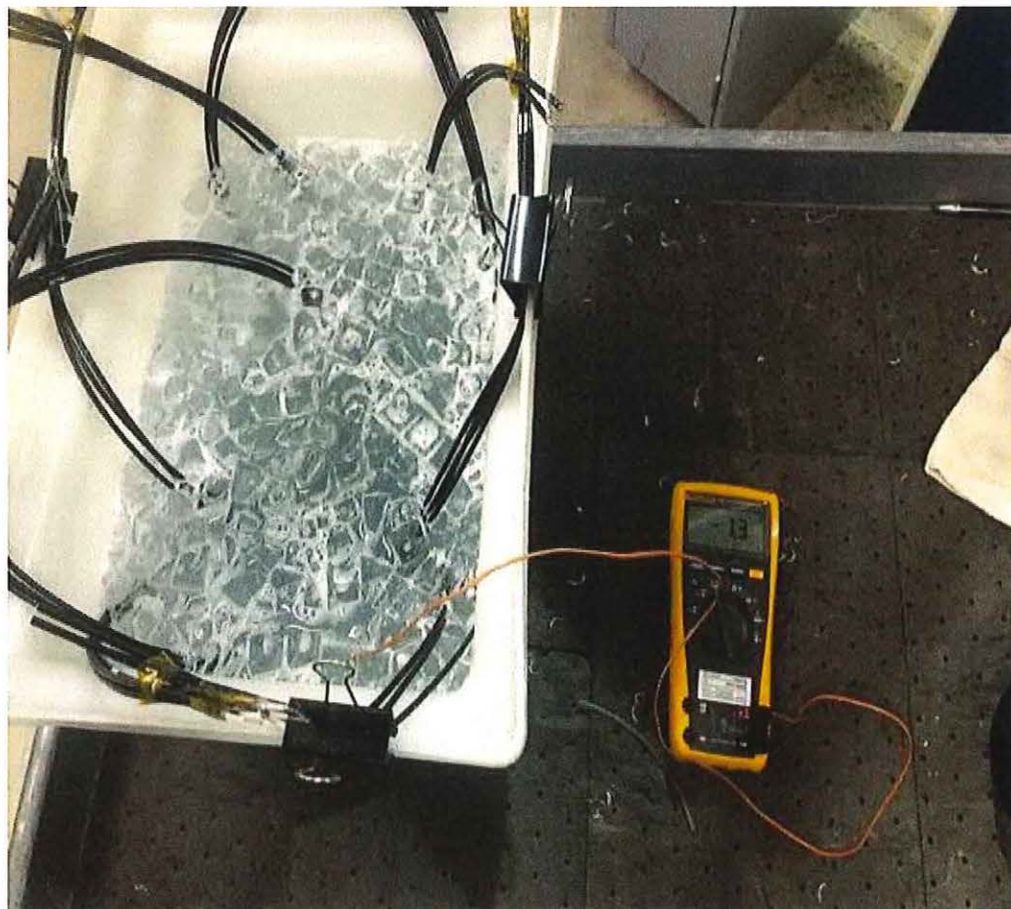
Figure 14: Thermal Shock Image

Each sample from Test Groups PG 23 Leg 1 and PG 23 Leg 2 experienced the same thermal shock testing. Samples were placed in an oven at 105°C for 30 minutes. Samples were then immediately transferred into a 0°C salt water solution with 5% salt and 10mL/L of dish soap for 15 minutes.

This was repeated for 5 cycles. An image of this testing can be found in Figure 14.
