M300 ASSEMBLY TOOL Z300-902

INSERTION PROCEDURE

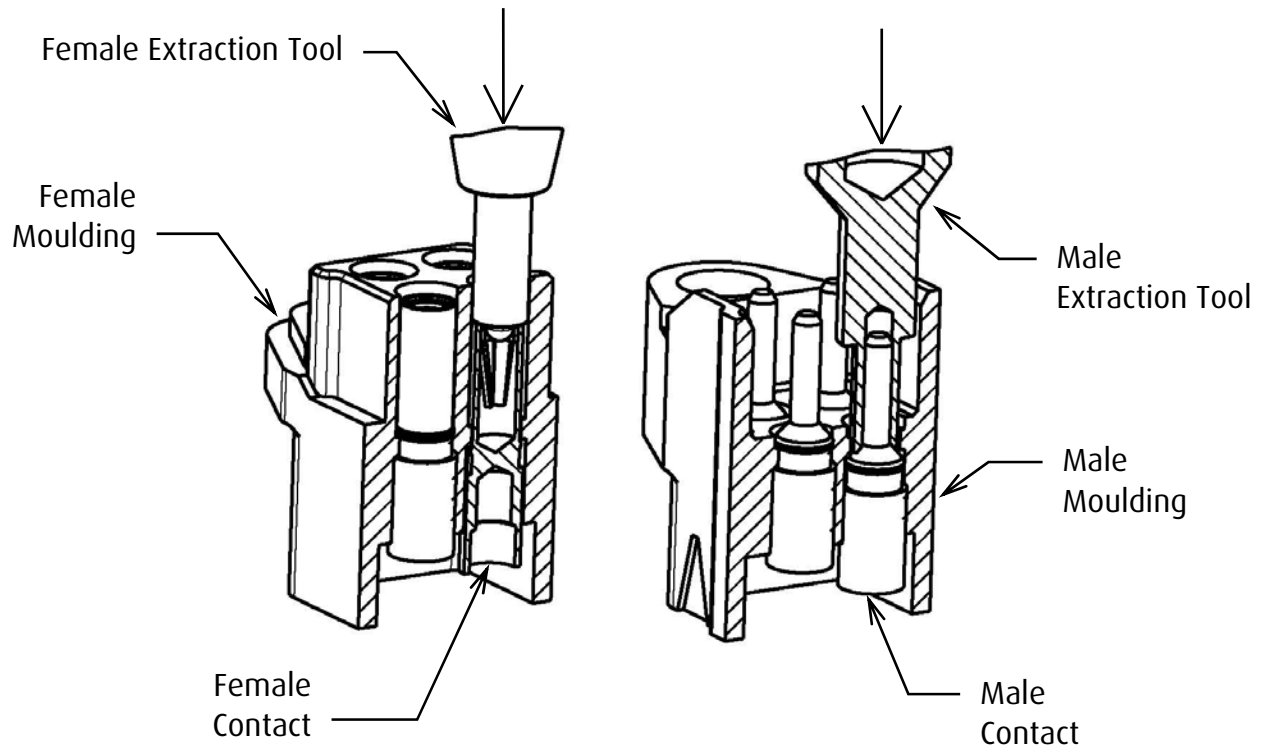
Figure 4

To remove a contact from the moulding, select the appropriate Extraction Tool from the handle and attach as before. Place this tool over the mating end of the contact and push firmly. Care should be taken to keep the tool perpendicular to the mould face, or mould damage may occur.
