Intel[®] Atom[™] Processor E6xx Series

Specification Update

July 2014

Revision 017

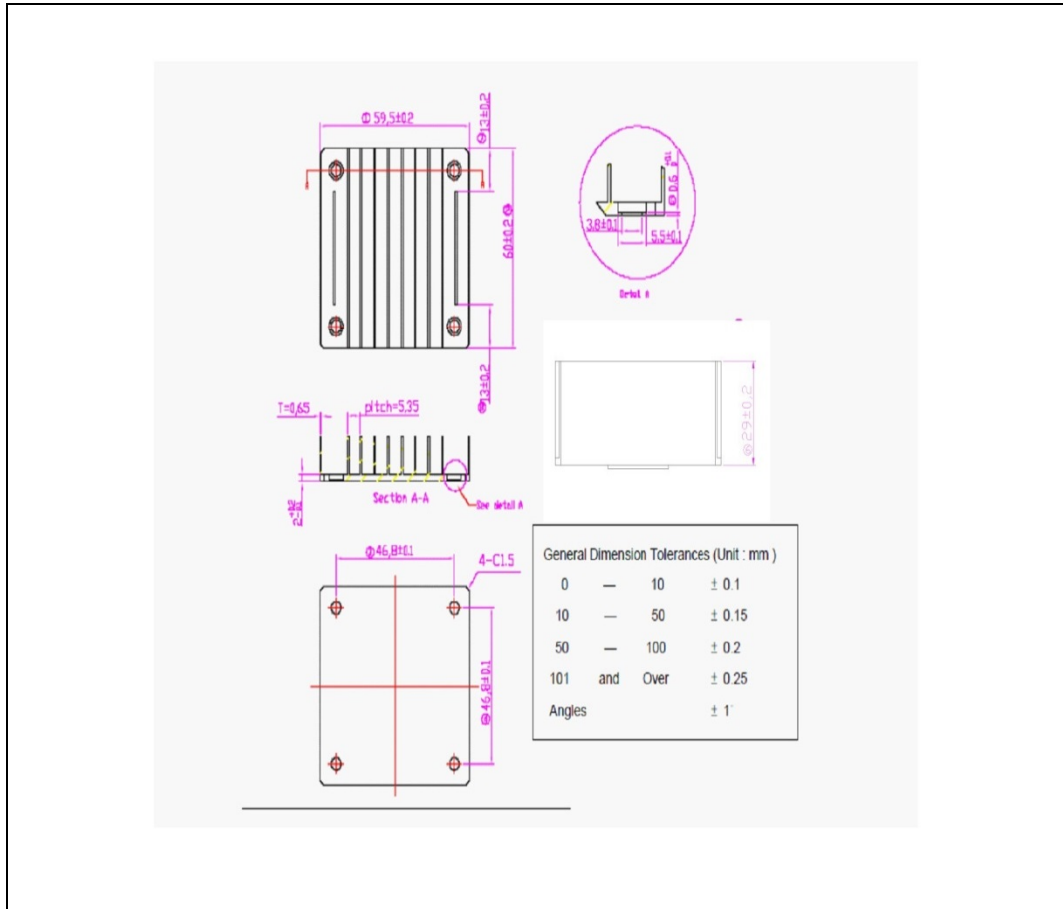
Figure 10. 1U Natural Convection Heatsink Mechanical Drawing

Issue: Heatsink height on Figure 10 “1U Natural Convection Heatsink Mechanical Drawing” has changed from 13.5 ± 0.2 mm to 29 ± 0.2 mm.

New Text:

Affected Docs: Figure 10 “1U Natural Convection Heatsink Mechanical Drawing” of *Intel® Atom™ Processor E6xx Series Thermal and Mechanical Design Guidelines, Rev 003*.
