FK135

(Former FX135)

3.2mm x 1.5mm
SMD Tuning Fork

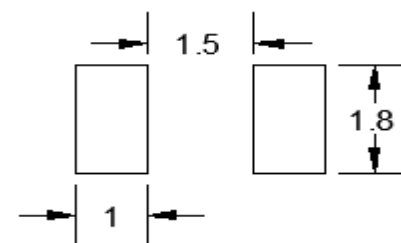
Recommended Solder Pad Layout

Dimensions in mm

Note: Dimensional drawing is for reference to critical specifications defined by size measurements. Certain non-critical visual attributes, such as side castellations, etc. may vary.

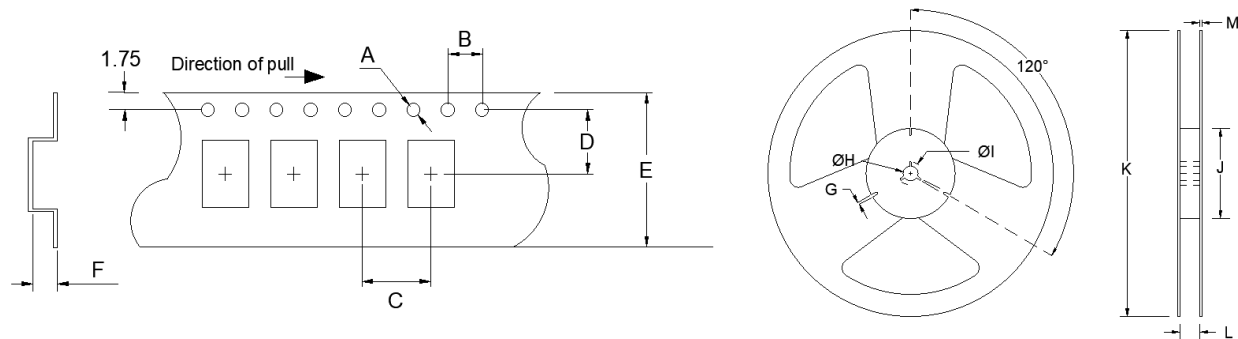
TAPE SPECIFICATIONS (mm)							REEL SPECIFICATIONS (mm)						
A	B	C	D	E	F	REEL QTY	G	H	I	J	K	L	M
Ø1.55	4.0	4.0	5.5	12.0	1.0	-T3 = 3,000	2.0	Ø13	Ø21	Ø60	Ø180	13.0	1.2

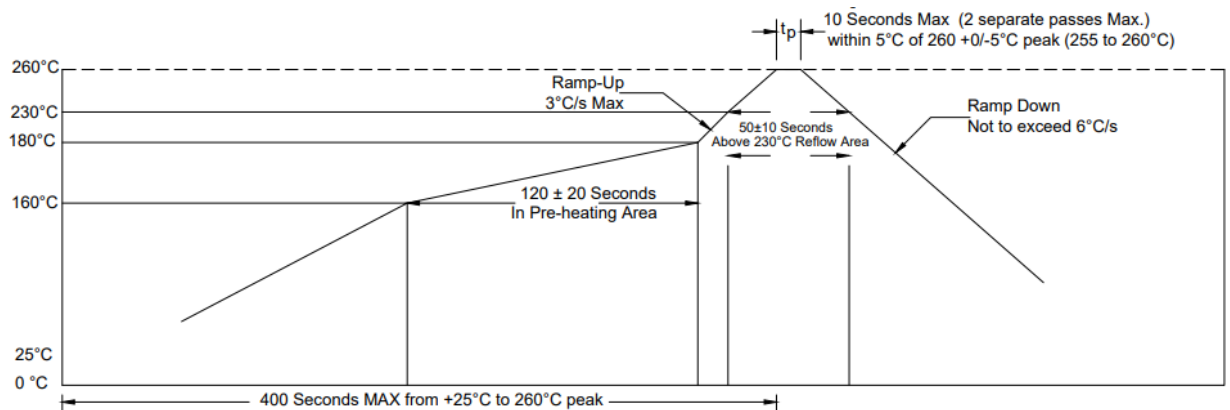
Following is typical SMD Pb-free reflow profile for soldering:

Excessive heating time at high temperature may result in deterioration of the characteristics and may break the crystal unit. For manual rework, heat the lead part at 300°C or lower for 5 seconds or less.
